CASE STUDY

A ROYAL SOLUTION

CASE STUDY Ref: Coating of Main Transverse and Intermediate Transverse Beams, Splash Zone Area for one of the world's biggest Synchronized Ship Lift Systems

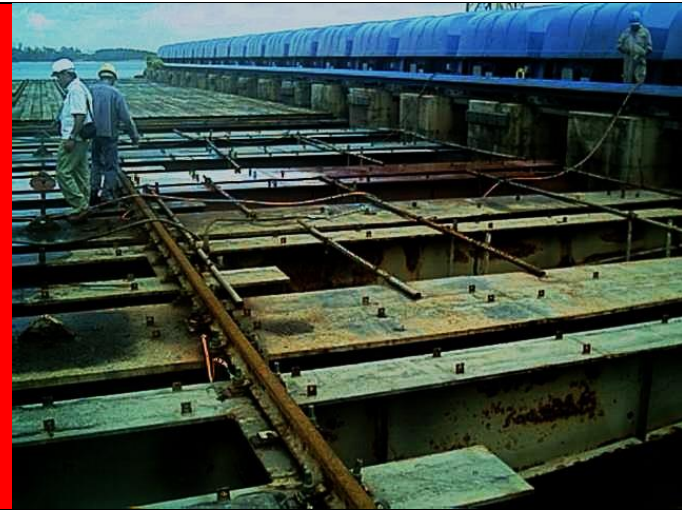
Picture showing timber Sleepers removed exposing both Main Transverse and Intermediate Transverse Beams. **Date of work commencement 15th March 2002**

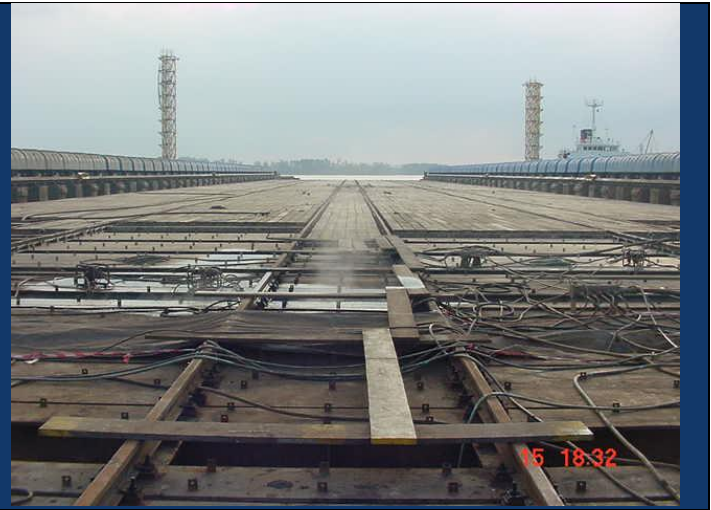
Picture showing timber Sleepers removed exposing both Main Transverse and Intermediate Transverse Beams. **Date of work commencement 15th March 2002**

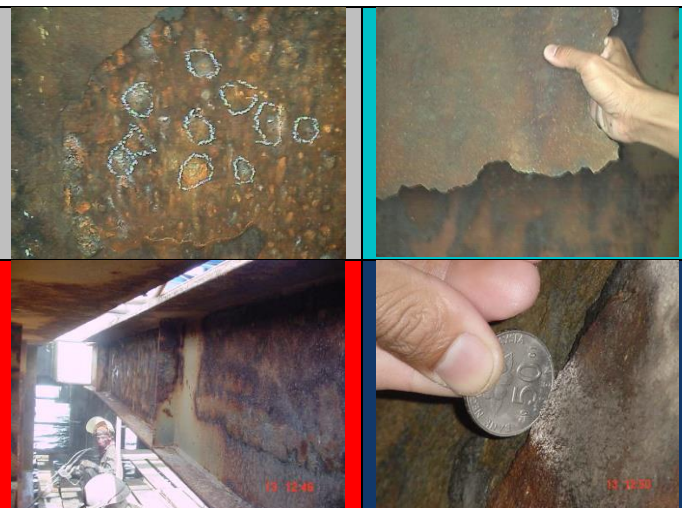
Previously installed coating system comprising of MIO Zinc Primer/Top Coat from a major coating manufacturer failed prematurely within 6 months of installation. The challenge was to re-coat all 50,000m2 of coated area while the Ship Lift was fully operational. The coated areas were in the Splash Zones subjected to cyclic wet and dry conditions with salt spray constantly present. Surfaces were completely submerged during Ship Lift Operations.

Pictures showing initial substrate conditions with heavy pitting original coating delaminating. **Date of Work commencement 15th March 2002**

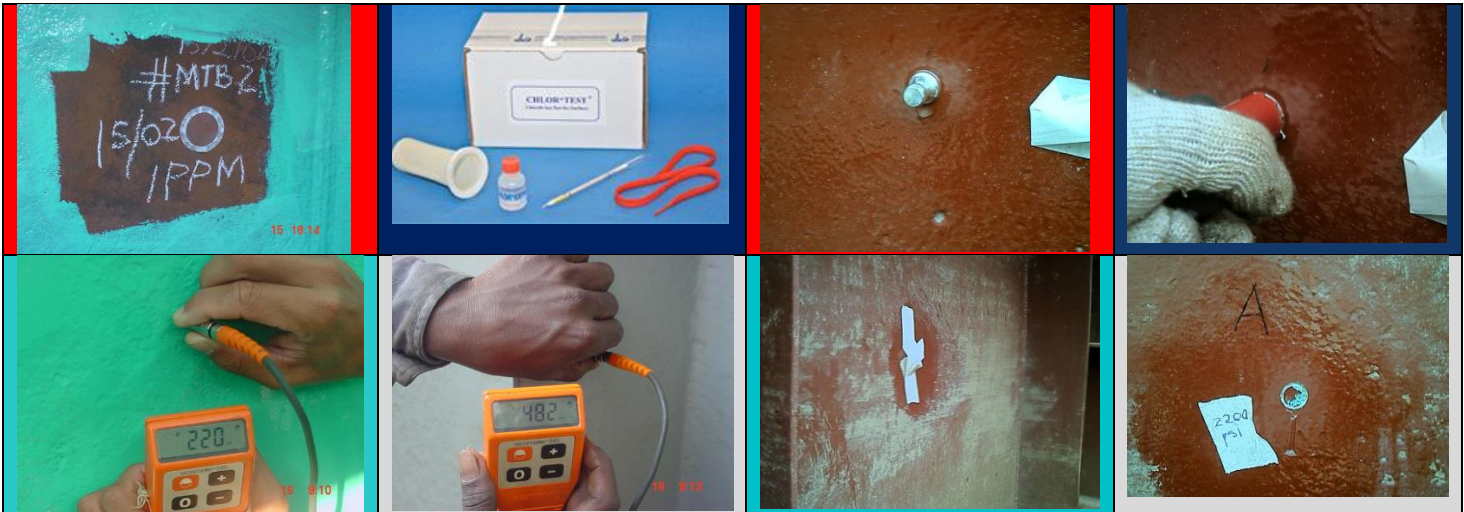
Pictures showing ITP being carried out. Measurements for Dissolved Salts were carried out using CHLOR*RID test kits. UT Gauges were used to measure DFT's.

Pictures showing Adhesion Pull Off Tests being carried out after coating system installation in accordance with ASTM D4541

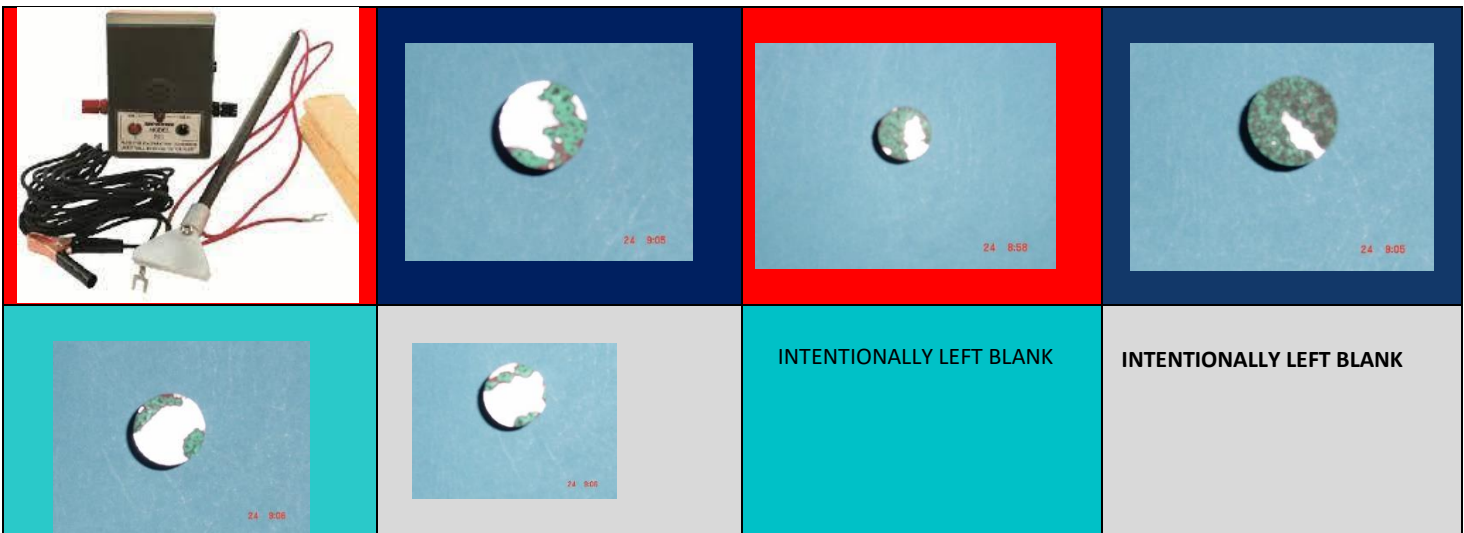
Pictures show ITP being implemented using equipment (Tinker and Razor Wet Sponge Holiday Detector) and Dollies after conducting Pull off Tests. Preceding page summarizes Adhesion Pull off Test results on a typical Main Transverse Beam

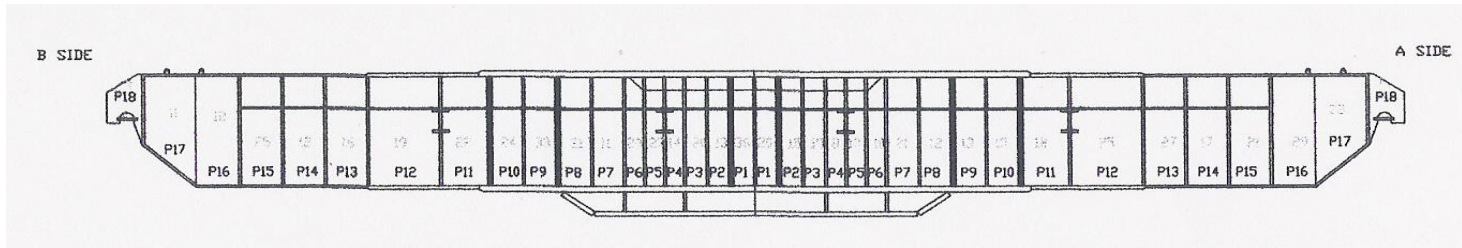
MTB #24 SEA END AREA A SIDE, PICTURE LOCATOR, 3 YEARS INTO COATING SYSTEM SERVICE LIFE

<p>P18A</p>	<p>P17A</p>	<p>P2A</p>	<p>P15A</p>
<p>P14A</p>	<p>P13A</p>	<p>P12A</p>	<p>P11A</p>
<p>Inspection carried out on 22nd Feb.2005. Year 3 in service. Less than 3% coating breakdown, well below threshold value for “Fair Wear and Tear”. MTB # 24 coating condition/breakdown reflective of all MTB’s inspected.</p>		<p>Inspection carried out on 22nd Feb.2005. Year 3 in service. Less than 3% coating breakdown, well below threshold value for “Fair Wear and Tear”. MTB # 24 coating condition/breakdown reflective of all MTB’s inspected</p>

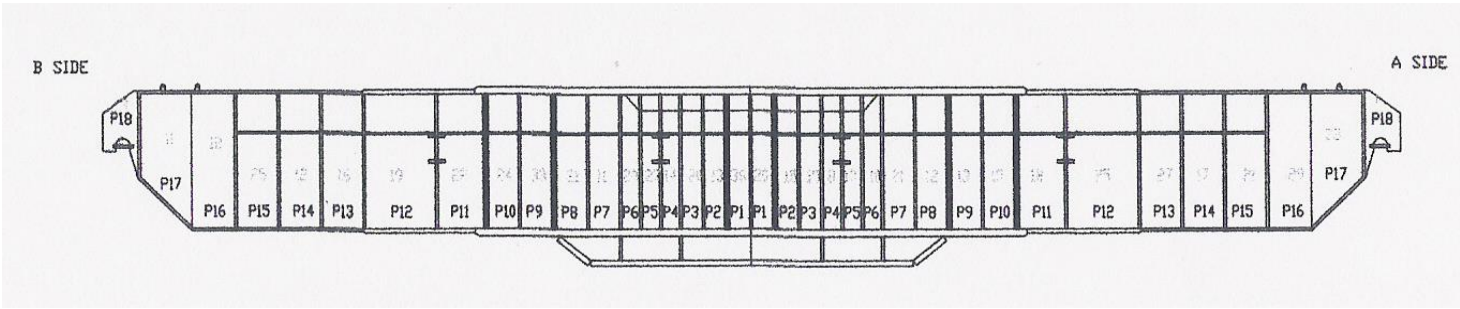
MTB #24 SEA END AREA B SIDE, PICTURE LOCATOR, 3 YEARS INTO COATING SYSTEM SERVICE LIFE

<p>P18B</p>	<p>P17B</p>	<p>P16B</p>	<p>P15B</p>
<p>P14B</p>	<p>P13B</p>	<p>P12B</p>	<p>P11B</p>
<p>Inspection carried out on 28th Jul.2005. Year 3 in service. Less than 3% coating breakdown, well below threshold value for "Fair Wear and Tear". MTB # 24 coating condition/breakdown reflective of all MTB's inspected.</p>			
<p>P10B</p>	<p>P9B</p>	<p>P8B</p>	<p>P7B</p>
<p>P6B</p>	<p>P5B</p>	<p>P4B</p>	<p>P1B</p>
<p>Inspection carried out on 28th July.2005. Year 3 in service. Less than 3% coating breakdown, well below threshold value for "Fair Wear and Tear". MTB # 24 coating condition/breakdown reflective of all MTB's inspected.</p>

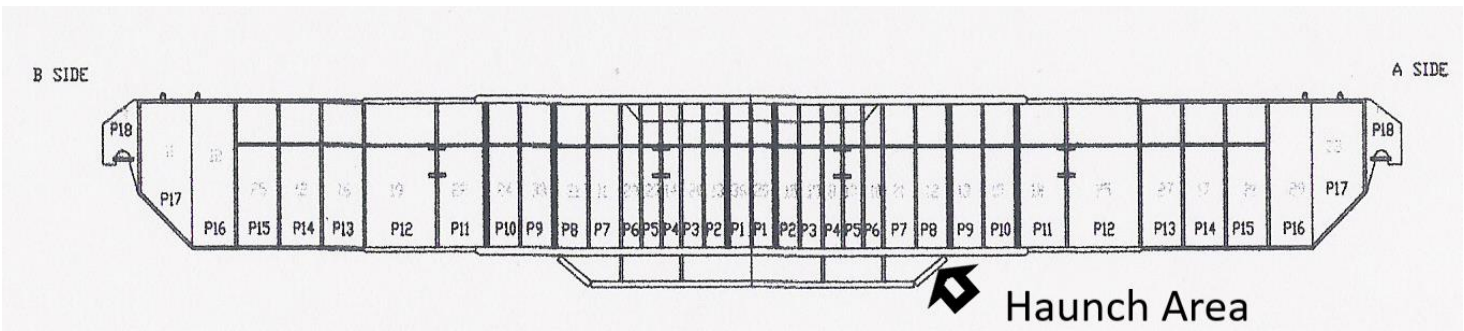
MTB # 24-HAUNCH AREA, 3 YRS INTO COATING SERVICE LIFE Date of Inspection: 22/02/05

The Haunch Area of the MTB falls within the tidal zone and is subjected to heavy fouling. Some areas of the Haunch were left uncoated due to accessibility issues. The Haunch Area was not covered by Royal Coatings Inc.'s limited warranty because of the above reasons. Fouling causes secondary microbial induced corrosion. Even under these extreme conditions the Haunch Area that was coated had very little corrosion.

<p>INTENTIONALLY LEFT BLANK</p>	<p>INTENTIONALLY LEFT BLANK</p>		<p>INTENTIONALLY LEFT BLANK</p>
<p>Areas NOT coated due to accessibility issues. Heavy fouling and corrosion. The Haunch Area was not covered by RCI's limited warranty</p>		<p>Areas that were coated with Easy Prime and Easy Guard showing very little corrosion.</p>

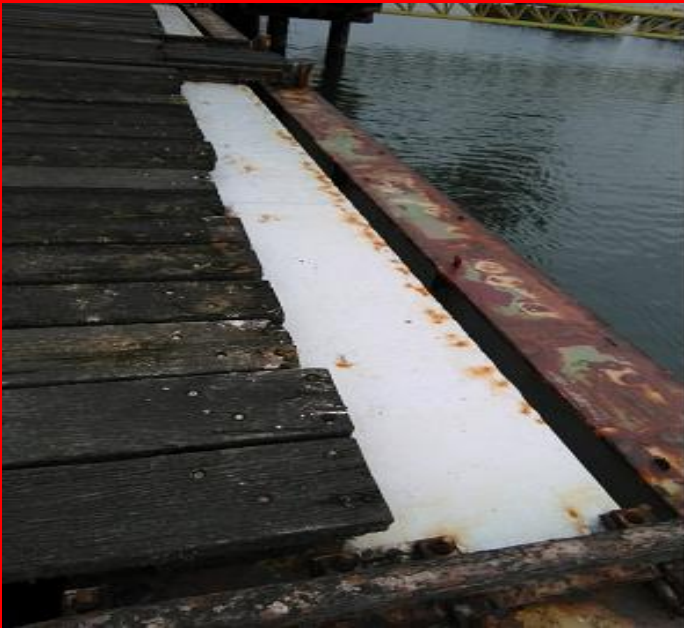
MTB, LAST BEAM SEAWARD END 16 YRS END COATING SERVICE LIFE.

The Royal Coatings Inc Coating System gave a Service Life of **16 Years** for a **C5-M** Environment (Very High Maintenance Marine-Coastal and offshore areas with high salinity) in accordance with **ISO1 12944-2** Classification of Environments. Factoring in cyclic load stresses, cyclic immersions and only **1 routine maintenance in the 3rd year** of coating service life this performance is exceptional. The above picture shows the last MTB Seaward end where the corrosion was heaviest with nearly 70% coating breakdown after 16 Years

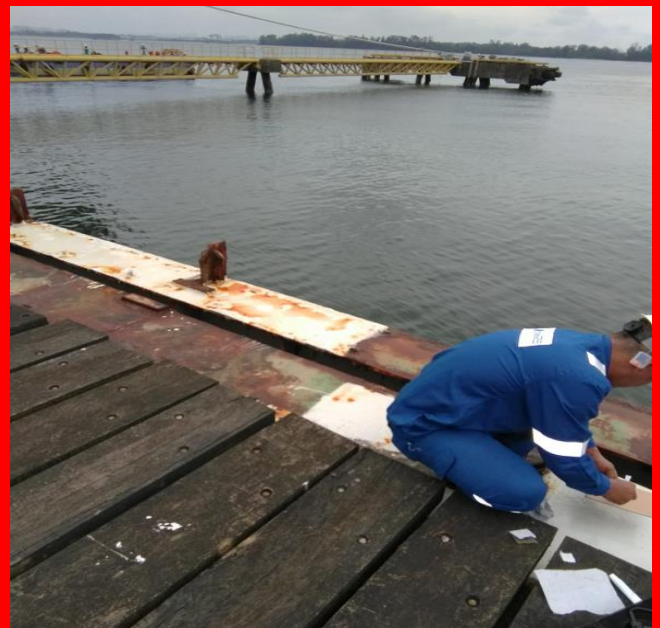
The Royal Coatings Inc Coating System gave a Service Life of **16 Years** for a **C5-M** Environment (Very High Maintenance Marine-Coastal and offshore areas with high salinity) in accordance with **ISO1 12944-2** Classification of Environments. Factoring in cyclic load stresses, cyclic immersions and only 1 routine maintenance in the 3rd year of coating service life this performance is exceptional. The above picture shows the last MTB Seaward end where the corrosion is heaviest with nearly 70% coating breakdown after 16 Years.
